***2017 ASPECT Preliminary Report
Rapids Needs Assessment &
Arkema Plant Response, Crosby, TX***

***September 2, 2017
0700 hrs to 2200 hrs***

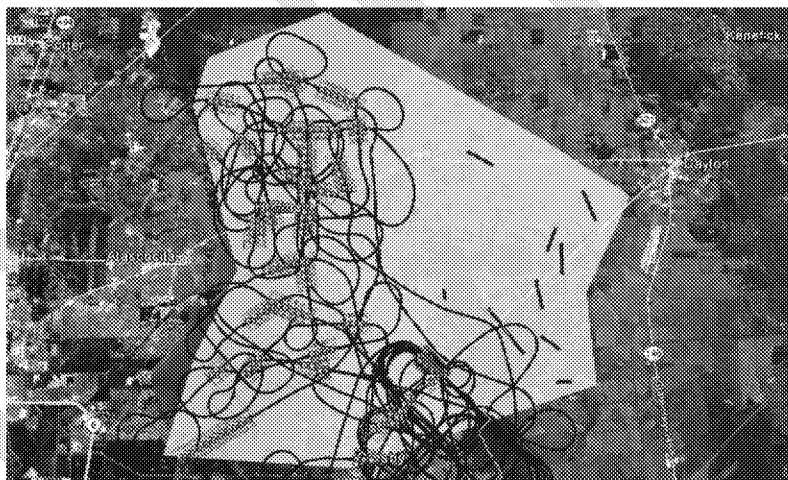
Figure 1: Rapid Needs Assessment flight lines showing aerial photographs. The lines are locations yet to be photographed. The Arkema facility is just northeast of Crosby. Flight occurred on 1 September 2017.

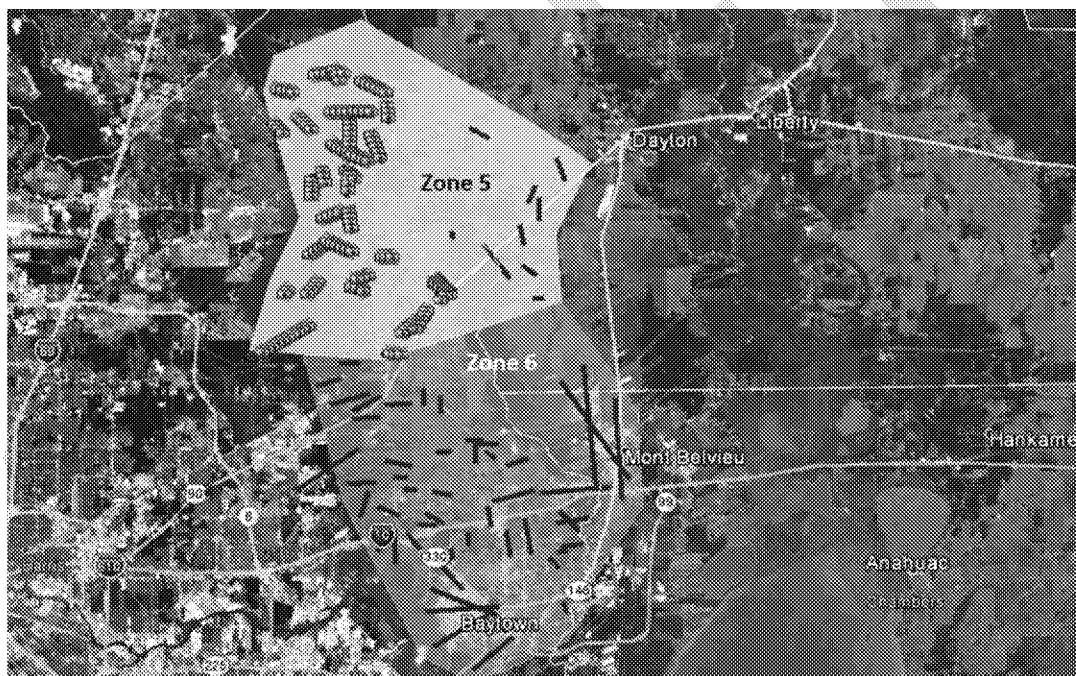
Figure 2: Flight lines in Zones 5 & 6 showing where aerial photography was taken over selected targets on 1 September 2017 for the rapid needs assessment.

On 1 September 2017, ASPECT completed about 50% of Zone 5 (Crosby to Huffman) consisting of approximately 50 targets (36 flight lines). Zone 6 (Crosby down to Baytown) consists of more than 50 targets (49 flight lines).

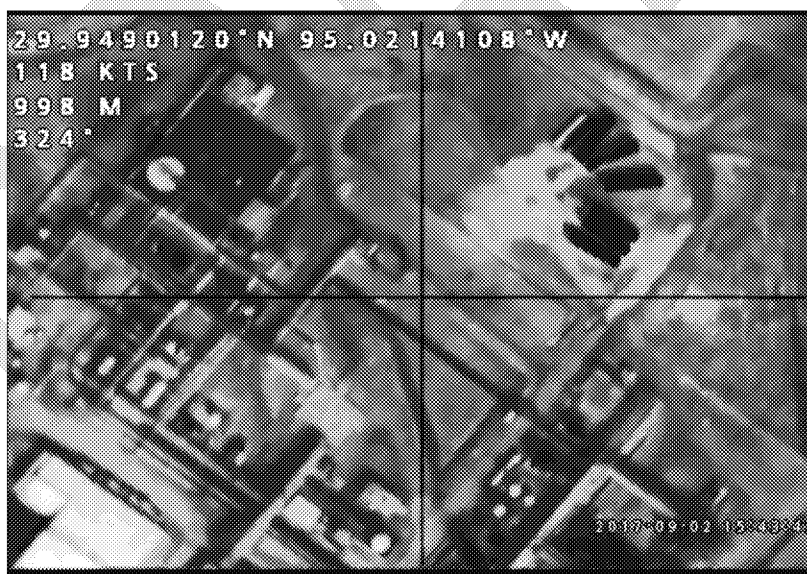
0820 hrs: ASPECT completes a pass over the Arkema facility and reports no significant chemical detections. Figure 4 is an image taken from the IR video showing the remaining refrigerated trailers.

Figure 4: Infrared image taken from the IR video over the six remaining refrigerated trailers.

The image in Figure 4 shows that the trailers appear to be cooler than the surrounding environment at this time suggesting that the ground may be solar heating and increasing the contrast between the trailers and ground.

1145 hrs: ASPECT completes a pass over the Arkema facility and reports no significant chemical detections. IR video continues to show similar images as shown in Figure 4.

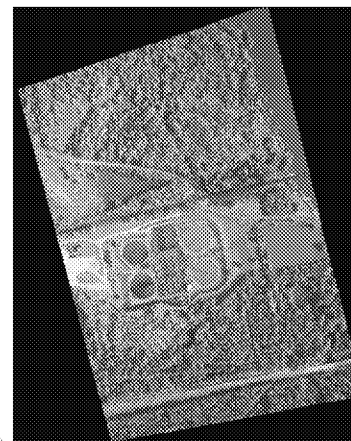
Figure 5: Example of a geo-corrected aerial photo over a water treatment facility. These are part of the rapid needs assessment mission.

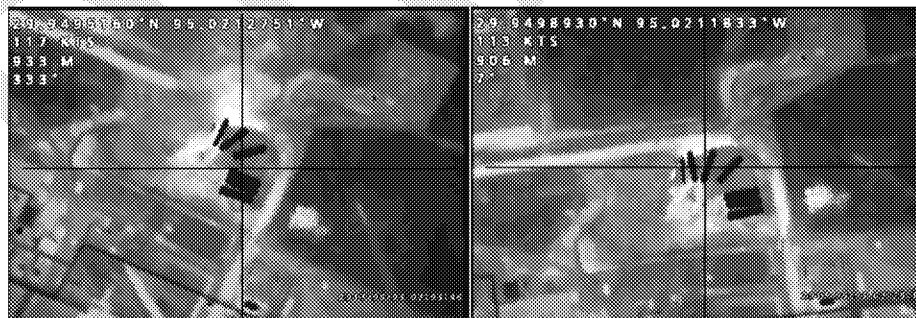
2100 hrs: Local authorities report that one of the trailers is leaking. ASPECT confirmed smoke and made a chemical sweep directly over the trailers. Many chemical detections were made consistent with light hydrocarbons (e.g., 1,3-butadiene) caused by the heated constituents emitted from the trailers. These hydrocarbons were all measured slightly above the limit of detection (about 5 ppm). Other downwind passes (50 m to 100 m) did not show chemical detections above the detection limits. Figure 7 shows two infrared images from independent passes 30 minutes apart.

Figure 7: Infrared images (2100 hrs on left; 2130 hrs on right) taken from IR videos show one of the trailers expelling heat from both ends.
